Bureau of Mines and Mine Safety  
Final Report  
Date: April 25th, 2014  
Fatality Report from October 11, 2013  
Five Star Mining Incorporated  
Prosperity Mine  
Prepared by Donald "Blink" McCorkle  
Assistant Commissioner

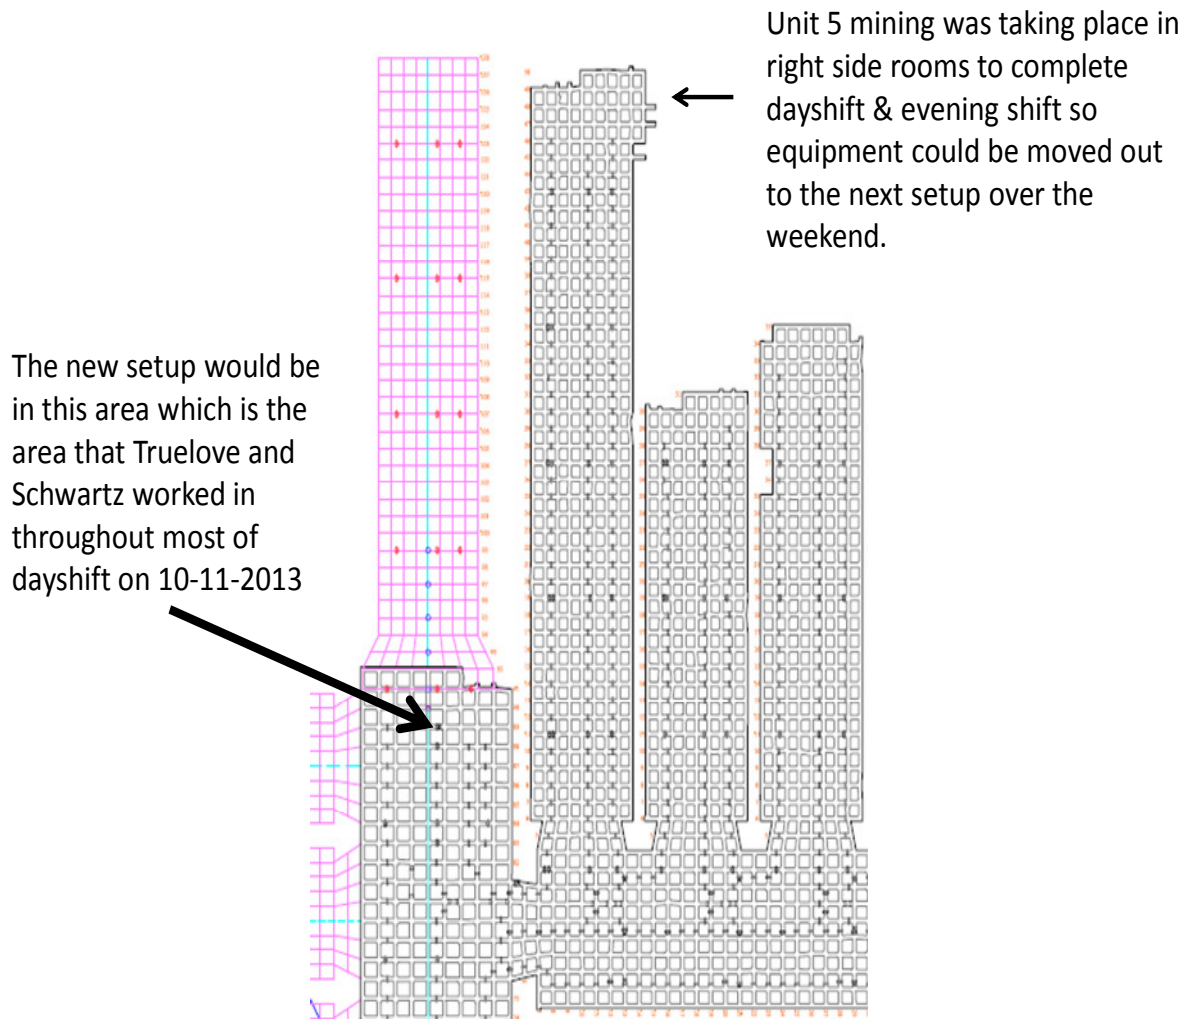
Diagram A

On Friday, October 11, 2013, the Dayshift (B) Crew at 5 Star Coal Company's Prosperity Mine, MSHA ID # 12-02249, entered the mine at 7:00 am. They traveled to the #5 Unit (see diagram A) and arrived at 7:40 am. Unit # 5 was a fishtail unit normally running the left and right side of the unit with two mining machines and two shuttle cars per side, a bolter per side and two loading crews. Chris Tooley, (SECTION MINE FOREMAN), started his on- shift examination at 8:00 am.

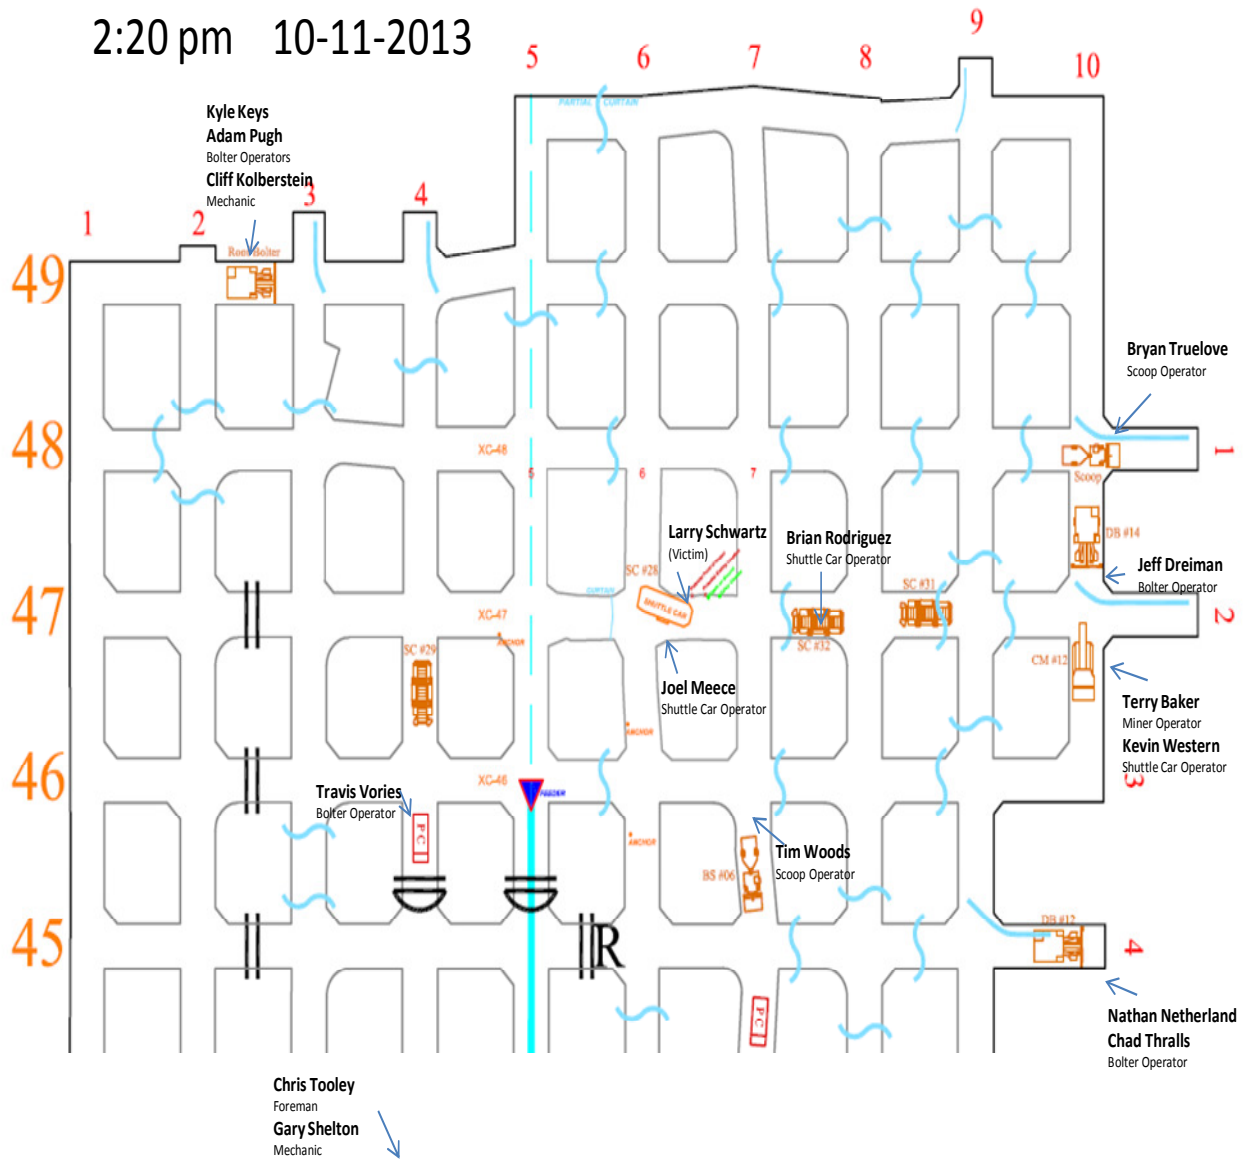
Diagram B

October, 11th, 2013, Friday, at approximately 2:20 pm, 59 year old Larry W. Schwartz (victim), was injured when he was caught between a shuttle car and a coal rib on the # 5 Unit at Prosperity Mine. The victim died approximately 2 hours after the incident. The victim was in the crosscut between the #6 and #7 entries (refer to diagram B.)

Both Schwartz and Truelove proceeded to the section loading point. Truelove left Schwartz at the feeder while he proceeded to go inby to get the scoop and scoop #1 room as he was directed. Schwartz left the loading point to proceed to the miner to tell Baker that he would be the papered person on the unit while the section foreman was gone. Schwartz traveled from the feeder to #47 xcut between #5 and #6 entries and talked to Meece. The #28 shuttle car was parked at a check curtain located near the #6 intersection in crosscut #47. After a brief conversation and before Schwartz proceeded inby he asked Meece the direction of travel of the #28 shuttle car. Meece told Schwartz he would be traveling to #7 entry and would be turning left toward crosscut #48 and then to the last open crosscut for the next cut in room #3 right (see diagram B). Schwartz then proceeded through the check curtain, flagged Meece, and verbally yelled "I am clear." Meece then proceeded to turn his shuttle car on, flashed the lights from the boom end to load end, rang the sounding bell, released his brakes and proceeded to travel through the curtain. He traveled approximately 48 feet when he heard someone yelling from the left side of his shuttle car. Meece stopped his shuttle car, set the brake, exited the cab and heard Schwartz yell "back up". He entered the cab, started his shuttle car, released the brakes, and backed away from Schwartz. He proceeded to the load end of his car to render aid to Schwartz, who had been struck by the shuttle car (See diagram B & C)

At 2:20 pm Brian Rodriguez (#32 SHUTTLE CAR OPERATOR), whose shuttle car was parked nearby between #7 and #8 entry in crosscut #47 (See diagram B) was the first to reach Schwartz, and was aided by Meece. They began administering first aid to Schwartz. The call out to the Communication center was at 2:25 pm and medical emergency units were notified. Between 2:20 pm and 2:35 pm several additional crew members came to render and assist in the first aid and transportation of Schwartz. At 2:50 pm the underground ambulance left with Schwartz to take him out of the mine. The underground ambulance reached the surface of the mine at 3:26 pm where it proceeded to the Landing Zone where and Air Evac Helicopter and the Pike county ambulance service waited to render medical aid. Medical personnel treated and transferred Schwartz onto the Air Evac helicopter to transport him to the University Hospital in Louisville, Kentucky. At 4:10 pm Mr. Schwartz passed away during the flight to the University Hospital. The mine was not notified of Mr. Schwartz's passing, until that evening around 10:30 pm, pending family notification.

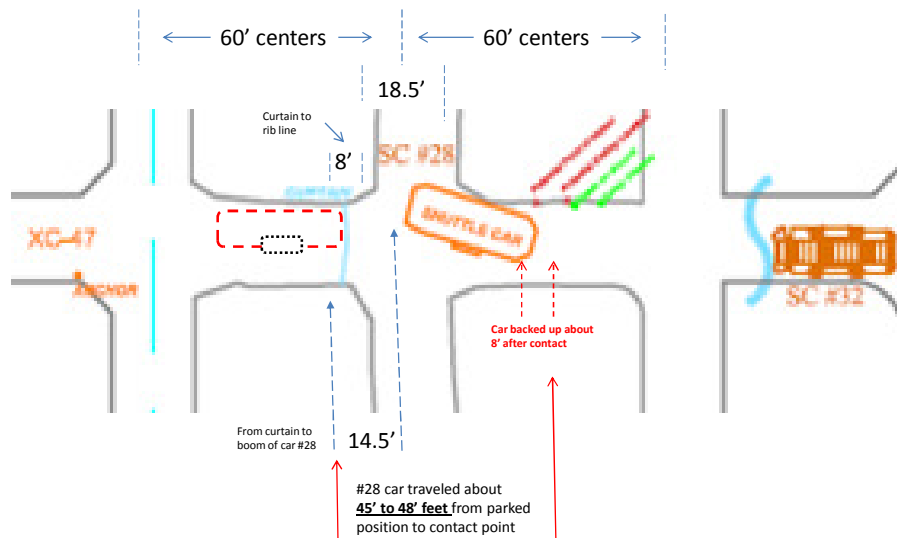
## Diagram C

### Distance & Timing Related to Accident on 10-11-2013

Testing estimated that the time from point of "I am clear" to contact was about **28 seconds**

The car operator, (Meece), in the interviews said that he turned his lights on from forward to reverse when he went through the curtain and the camera may not have picked up the light in front of the car instantaneously. There could have been a brief lag time before the camera focused, referring to Diagram C it was approximately 28 seconds from the time the car went through the curtain until the victim was contacted with the shuttle car. (The car was trammed through the curtain to ascertain a time line.) The operator also said the victim may have been out of the peripheral view of the camera and that he (Meece) was focused on another cable that ran through the crosscut, and that the victim could have been in the corner where the corner of the pillar had been trimmed off.
